# Potential Unintended Consequences Due to a Lack of Scientific Rigour

by Dr Angus Ramsay

This case study comes from a recent commercial project undertaken by the author at his engineering consultancy, Ramsay Maunder Associates (RMA). The owner of the crane contacted RMA after a recent inspection had revealed cracks in some of the main structural members. The owner had employed a reputable crane maintenance organisation to repair the cracks. This included two aspects, firstly, the gouging out and welding up of the crack and, secondly, the welding of a cover plate over the previously cracked region. The insurer of the crane asked the owner to provide confirmation that the stresses under and adjacent to the new cover plate were unlikely to cause problems with fatigue at a future date. A schematic of the overhead crane is shown in Figure 1. The regions where the two cracks were observed are highlighted and it is the crack at the northern end of the crane that we will consider in this article.

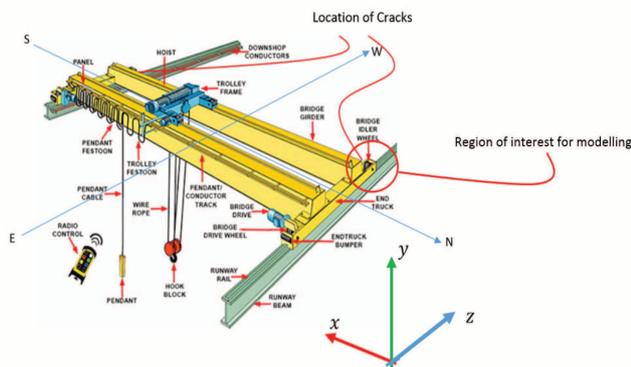
**Figure 1:** Schematic of the overhead crane highlighting the region of interest in this study

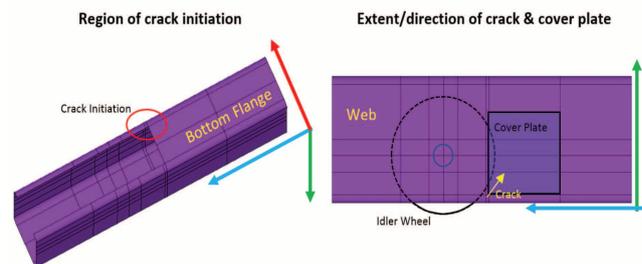
The crack in the region of interest emanated from a sharp corner where the bottom flange of the rectangular hollow section end truck member had been removed to allow the idler wheel to penetrate the member and reach the track on the runway beam – see Figure 2(a).

**Figure 2:** Crack initiation, direction of growth, extent and cover plate repair

At an inspection during my site visit it became apparent that the removal of the end portion of the bottom flange had been undertaken using some form of flame-cutting approach which left a rather poor finish of the sort that is fertile ground for early onset fatigue crack initiation. The cover plate used to repair the crack is shown in Figure 2(b). It is welded to the web of the end truck member around the four sides of the plate and the question posed by the insurers of the crane is how does this plate influence the stresses in the member. To answer this question some stress analysis is required both of the member alone and then with the cover plate welded on to it. But before presenting this, it is worth noting a brief history of the crane.

The repairs made to the crane appear to have been undertaken on the 'belt & braces' principle and without any consideration of the unintended consequences of the repair that a more detailed analytical approach might have brought up. It is the case that the gouging out and welding up of the crack should have returned the fatigue resistance back to the 'as new' condition, [3]. The re-initiation of the crack could have been ameliorated and potentially stopped by addressing the poor geometry and surface finish at and adjacent to the sharp corner where part of the flange had been removed. It is also noted that the repair work was undertaken when the crane was unloaded. A more thoughtful approach might have been to repair it when fully loaded since by doing so a decent set of compressive residual stresses would have been gained for any future loads up to the fully loaded condition. And, finally, the whole area could have been treated with shot-peening to impart residual compressive stresses to the surface of the member to discourage future crack initiation. The purpose of the cover plate is unclear. It might, though, have been added as a gesture to increase the structural strength of the member should the crack reappear. The repairers would, I guess, be somewhat surprised to understand, as explained in this article, that by adding the cover plate they have reduced the fatigue resistance of the structure. As it happens, and it is guessed that this is purely by serendipity, the reduction in fatigue resistance is unlikely to result in crack initiation during the foreseeable remaining life of the crane.

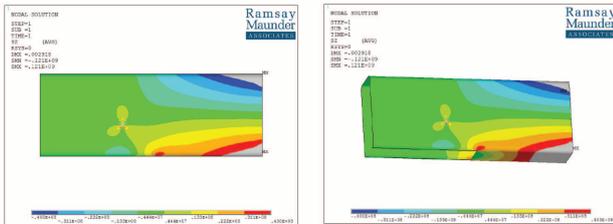
The contours of normal bending stress shown in Figure 7 agree extremely well with those calculated by hand. However, the stress distribution though now shows the local disturbances caused by the idealisation of the idler wheel axle as a point support and by the sharp corner of the flange cut-out.

**Figure 7:** Contours of normal bending stress at full payload (without cover plate)

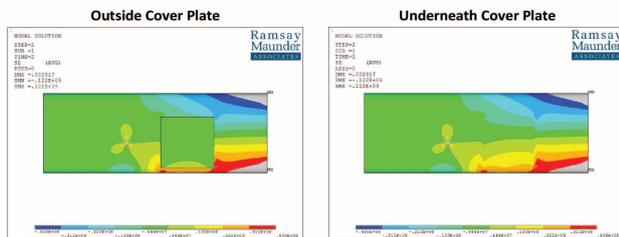
To model the influence of the cover plate correctly the analysis has to be split into two steps. In the first step the crane without the cover plate is analysed under dead load and then for the second step the cover plate is added and the live load applied. The contours of normal bending stress for the crane with the cover plate added are shown in Figure 8.

**Figure 8:** Contours of normal bending stress at full payload (with cover plate)

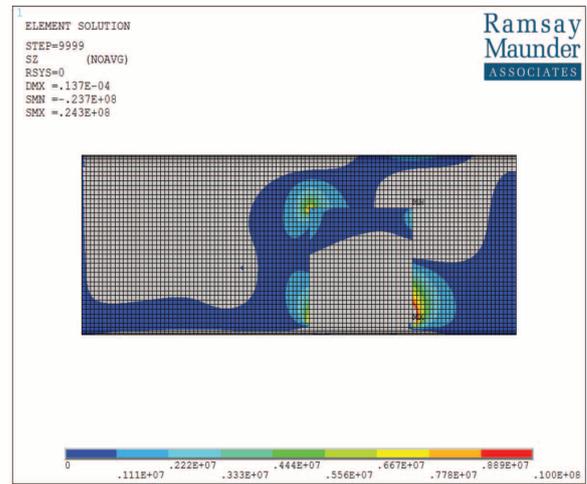
**Figure 9:** Contours of difference in normal bending stress for full payload

The contour levels in Figure 9 were chosen such that regions of negative stress, which indicate a reduction in stress due to the addition of the cover plate, are coloured grey. All other colours represent different ranges of increased stress and locate regions where the addition of the cover plate has impinged in a potentially harmful manner on the structural integrity of the member. It is noted that at the bottom left of the cover plate, where the original crack existed, the stresses have been reduced which might ameliorate crack growth should the crack reappear in the future. However, this has been at the expense of the top left corner and in particular the bottom right corner of the cover plate where the stress has been increased.

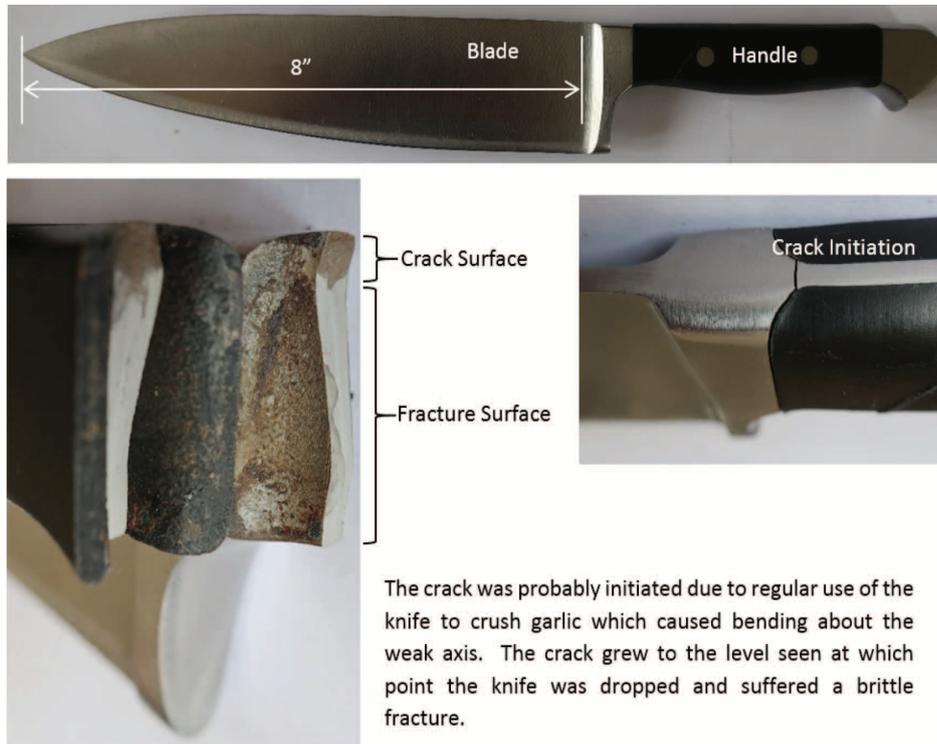
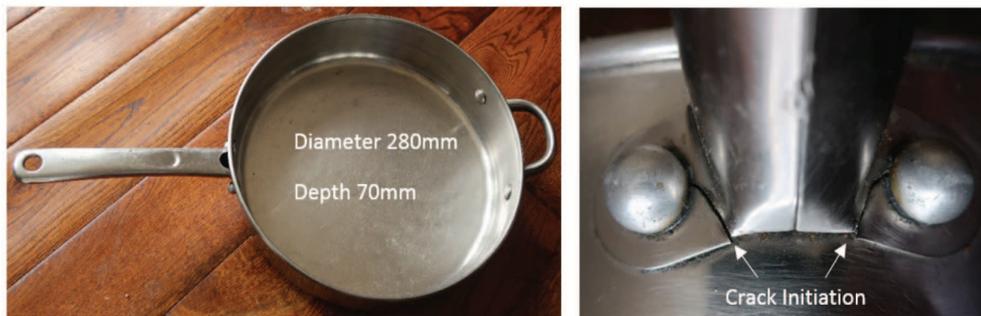
Figure 10:

**Figure 10:** Recent fatigue failures from the author's kitchen (picture on next page)

The cracks initiated at the sharp corners where the tabs for the two rivets used to join the handle to the pan were bent outwards from the pre-formed handle. The crack grew to the extent shown before the reduction in stiffness became noticeable. Had the pan continued to be used then it is likely that a ductile fracture would have been observed with the handle tearing from the pan.

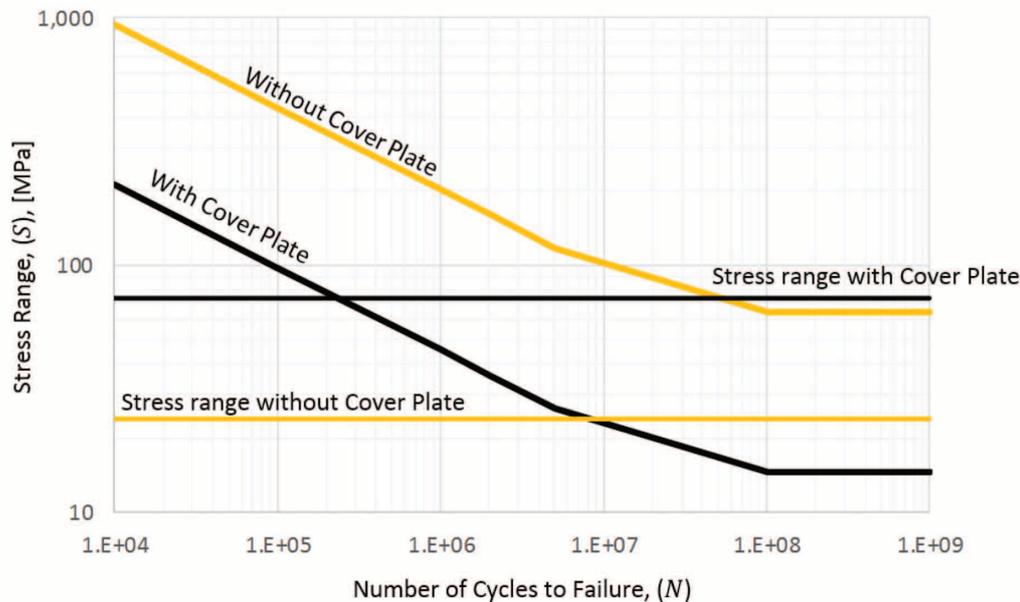
**Figure 11:** The lower and upper SN curves from Eurocode 9

It is seen from the annotated SNS curves of Figure 11 that whereas prior to the addition of the cover plate the stress range in that region was sufficiently low as to imbue an infinite fatigue life on the member, the addition of the cover plate leads to a finite fatigue life of just under 200,000 cycles.

In practice, under the current ownership, the crane is only loaded to 30% of its SWL and only undergoes about 20 lifts per day. However, on a conservative basis and taking the 200,000 cycles calculated for the full SWL cycle, the fatigue life of the crane is  $200,000 / 20 / 365 = 27$  years. The design life of the crane, when new, is not known although a reasonable life for an overhead crane might be 30 years. It has already served this period of time and so one might expect any further life to be a bonus.
