# Potential Unintended Consequences Due to a Lack of Scientific Rigour

by Dr Angus Ramsay

This case study comes from a recent commercial project undertaken by the author at his engineering consultancy, Ramsay Maunder Associates (RMA). The owner of the crane contacted RMA after a recent inspection had revealed cracks in some of the main structural members. The owner had employed a reputable crane maintenance organisation to repair the cracks. This included two aspects, firstly, the gouging out and welding up of the crack and, secondly, the welding of a cover plate over the previously cracked region. The insurer of the crane asked the owner to provide confirmation that the stresses under and adjacent to the new cover plate were unlikely to cause problems with fatigue at a future date. A schematic of the overhead crane is shown in Figure 1. The regions where the two cracks were observed are highlighted and it is the crack at the northern end of the crane that we will consider in this article.

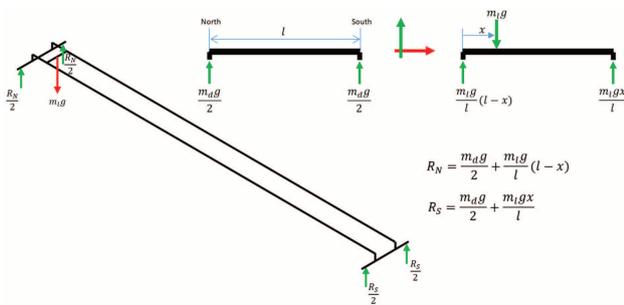
Figure 3: Free body diagram of the crane

The reactions due to dead and live load are shown in Figure 3. The live load can, of course, be positioned anywhere along the bridge beams, i.e.,  $0 \leq x \leq l$ , however, as we are interested in capturing the worst case with the highest live load reaction at the northern end of the crane, the case where the trolley is adjacent to the northern end of the bridge beams, i.e., with the smallest value of  $x$  possible, will be taken.

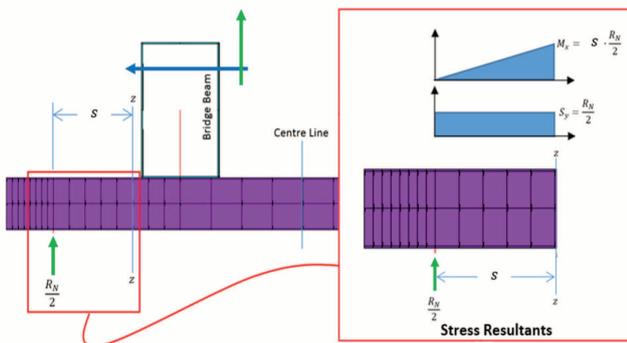
Figure 4: Stress resultants in region of interest

Thus, the reaction at the north-west crane wheel is half the total for the northern end trolley and the loading diagram shown in Figure 4 can be drawn. If we consider a cut through section z-z then the force and moment required to keep the section to the left of the cut in equilibrium are simply determined as shown in the right-hand part of the figure. Engineers tend to call these quantities ‘stress resultants’ and it is possible to draw diagrams of shear force and bending moment stress resultants showing how these vary in the region of interest.

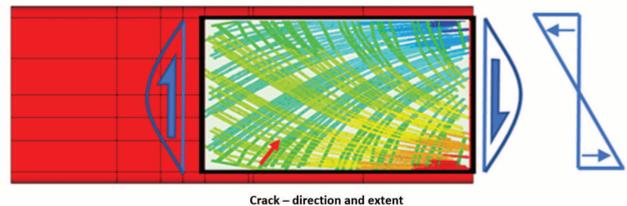
Figure 5: Stresses in region of interest

Once the stress resultants are known then using simple engineering theory for beam members, the stresses at any point across the depth of any section z-z may be determined. This theory tells us that the bending moment resultant produces a normal stress distribution that is linear through the depth of the member and a shear stress distribution which is parabolic. Whereas the shear distribution remains constant along the length of the region of interest, the linear normal stress distribution decreases (linearly) to zero at the point where the vertical reaction forces is applied, i.e., at the wheel. These stresses are shown in Figure 5 where principal stress trajectories have been used to represent the stresses. Principal stress trajectories are extremely useful to the practising engineer since they capture, in a single image, the load paths inside the member. They form a network of orthogonal lines and may be coloured according to the magnitude of the principal stress that they represent. Cracks tend to grow in a direction that is at 90° to the maximum principal stress trajectories, i.e., parallel to the minimum principal stress trajectories, and the direction and extent of the crack shown in the figure are consistent with the actual crack observed in the crane.

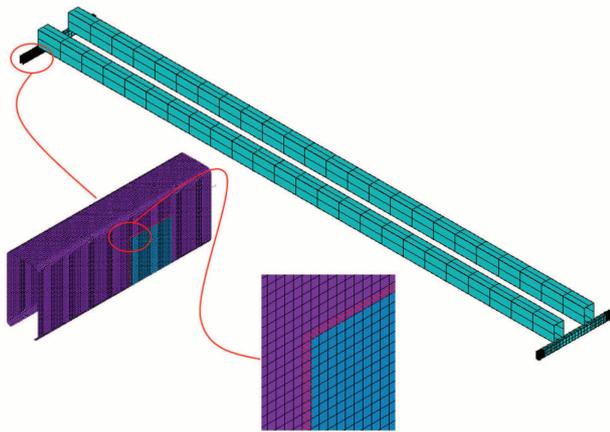
**Figure 6:** Beam/shell finite element model with removable cover plate

In a FE model, the structure is discretised using finite elements and there is a range of element types available to the engineer. In modelling the crane, I have chosen to idealise the majority of the structure using beam elements and then to idealise the region of interest, i.e., under and adjacent to the cover plate, using shell elements. The model is shown in Figure 6 where the cover plate is shown and the weld around the four sides of the cover plate is idealised using rigid-beam elements (shown as red lines).
