## Fatigue Assessment of a Machine Component

This case study describes a failure analysis project in mechanical engineering undertaken by Ramsay Maunder Associates (RMA) for a component in a machine for pelletising china clay.

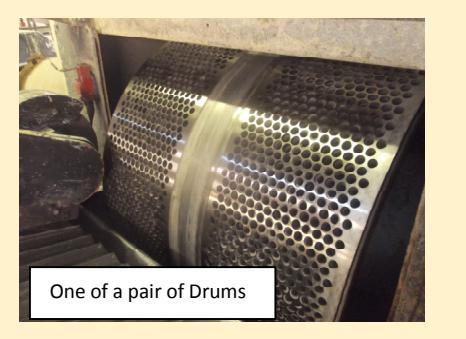
The pelletising machine comprises two counter-rotating perforated drums. The moist clay is fed between the drums and is forced through radial holes to form pellets.

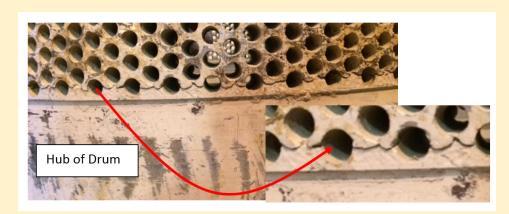
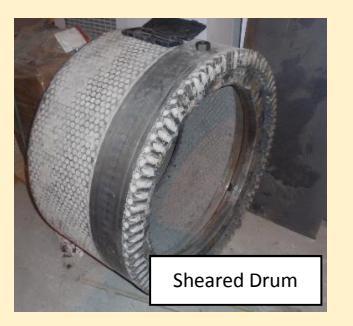
Over time, cracks appeared in the drums adjacent to the central hub which eventually led to the drum shearing completely.

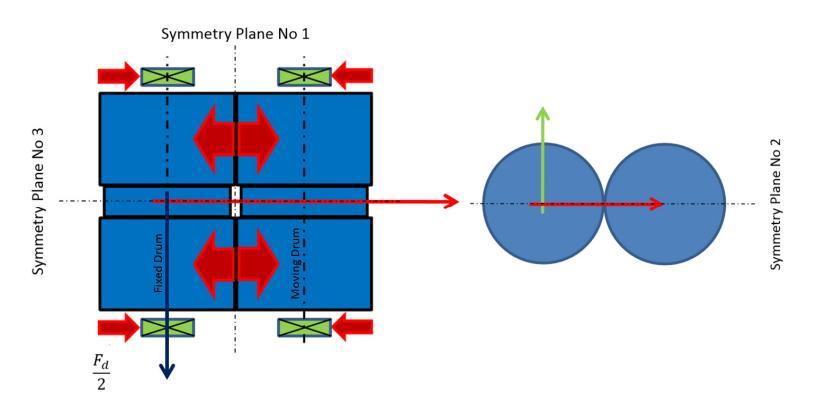
RMA conducted a detailed finite element stress analysis of the component and a fatigue assessment of the original design and a modified design where a ring of holes adjacent to the hub were removed. The drums of the palletising machine exhibited three planes of symmetry which were used to reduce the region that needed to be modelled to one-quarter of one drum.

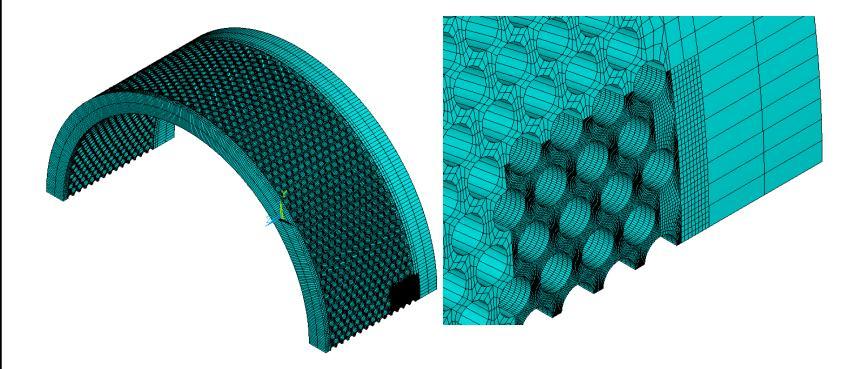
The highly-stressed region of the drum is along the line of contact and adjacent to the hub where the bending moment is a maximum. In order to obtain accurate results in this region a locally refined region was embedded in the mesh.

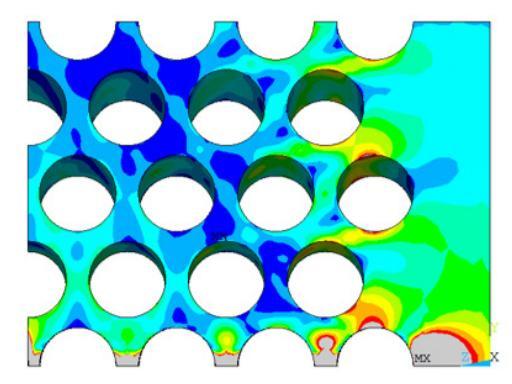
The stress distribution in the highly-stressed region, whilst showing artificially high stresses under the line contact, provided a realistic picture of how fatigue cracks, similar to those seen in practice, might develop in the component.

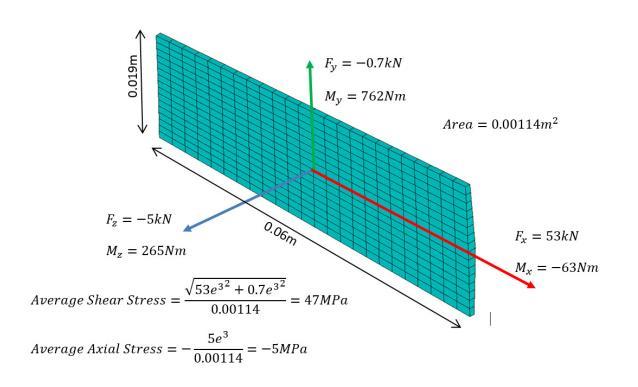
By considering the average stress on the lands lying between adjacent holes it was straightforward to rule out the possibility of shear failure from a single application of the load.

The peak stresses occurring on the land occur at the four corners and are, essentially, in the axial direction, i.e., they are driven by the bending moment. The stress at these points varies as the drum rotates and the finite element results can be used to establish the amplitude and mean stress values to be used in a fatigue assessment.

The fatigue assessment was conducted on the original design and on a modified design where the first ring of holes adjacent to the hub were removed. The bending moment drops rapidly as one moves axially away from the hub, and by removing the first ring of holes the maximum stress in the region drops considerably. The fatigue assessment was based on the conservative Soderberg approach and indicated that with the design modification, the component would have a significantly improved (possibly even infinite) fatigue life.
